# CONTROL SURVEY MONUMENT RECOVERY

Cathedral City

Number: **158**  
Name: **RM 12**

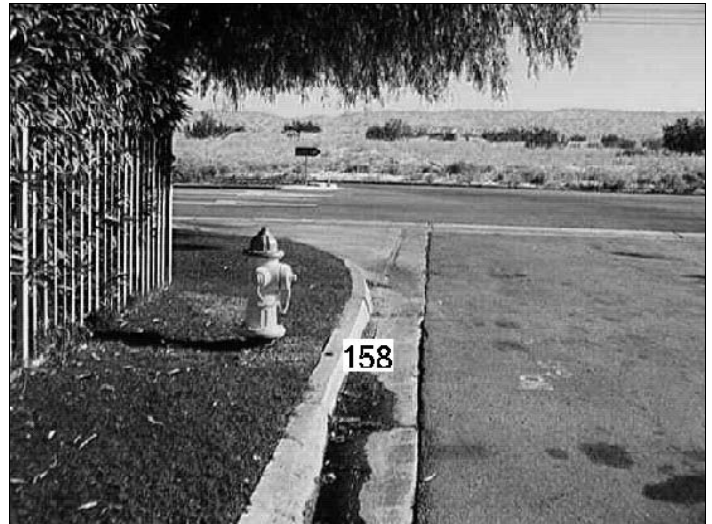
**Monument Description:** GPS Useable: No  
2.5" City Rcho Mirage bronze disk in top of curb

Southwest return on Frank Sinatra Dr at north entrance to Rancho Mirage Country Club

0.5 mi east of Bob Hope Dr; 6.6 ft south of southerly PCR

Looking North
